MATERIAL CHARACTERISATION AND CONDITION ASSESSMENT OF HISTORIC WALL MORTAR AT POONCH HOUSE, LAHORE-PAKISTAN: IMPLICATIONS FOR COMPATIBLE CONSERVATION

Keywords: historic lime mortar; SEM–EDX; XRD; ultrasonic pulse velocity; salt deterioration; heritage conservation; Poonch House, Lahore.

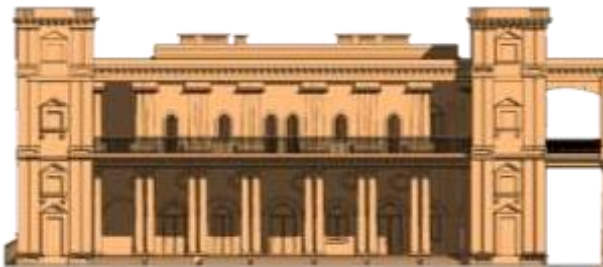
Figure 2. Elevations and 3D sectional view, Poonch House, Lahore

North Elevation

East Elevation

South Elevation

West Elevation

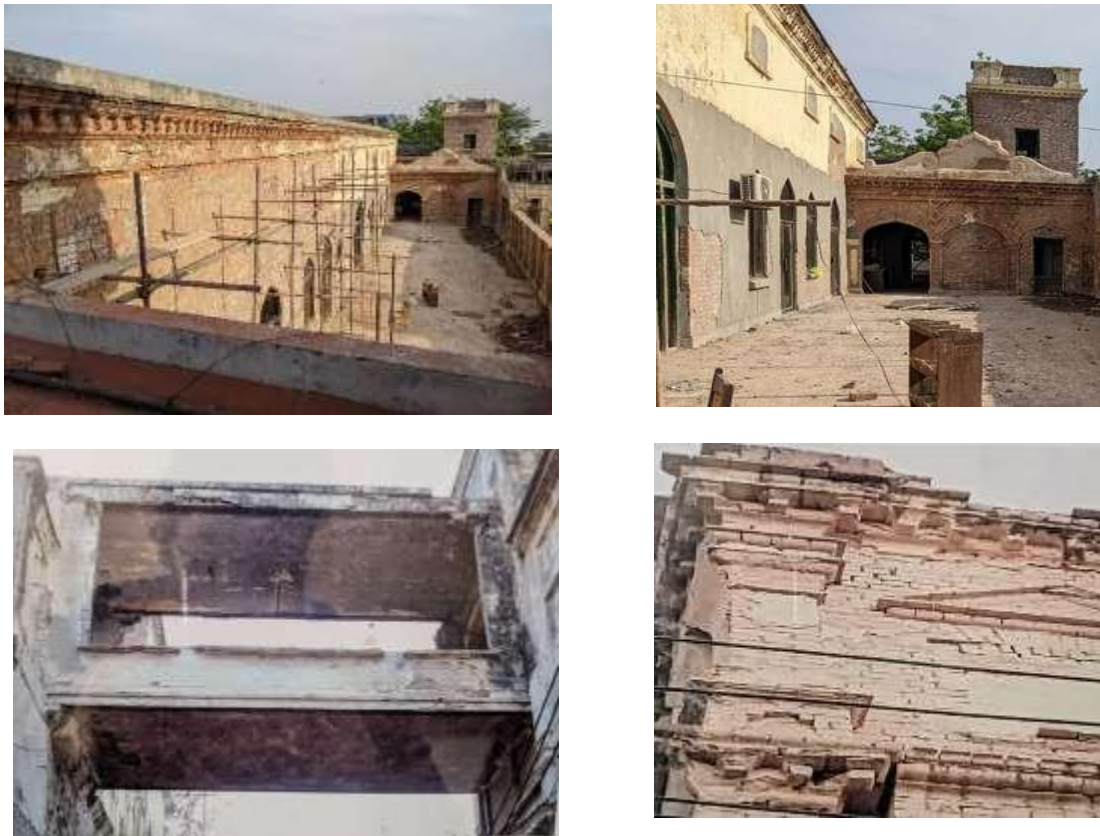
Figure 3. Few deteriorated spots observed on the façade and walls of Poonch House, Lahore.

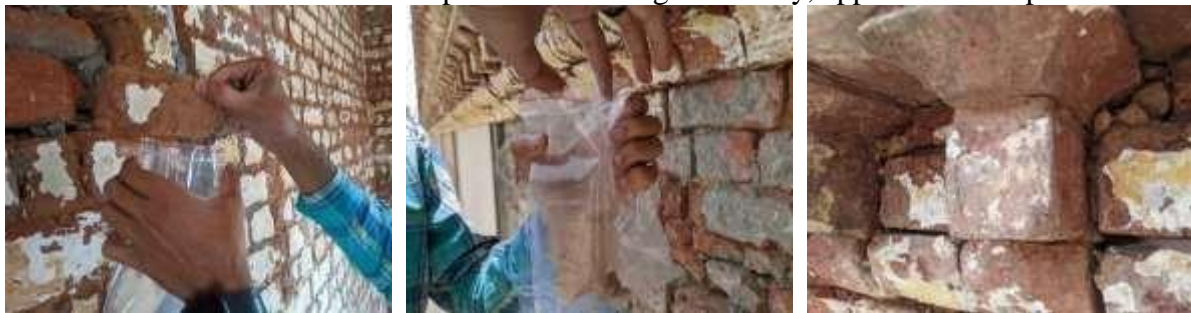
The sampling points (Figure 4) were placed on the evident deterioration characteristics (cracking, spalling, efflorescence, or cementitious over-repairs). One sample (30-50g) each was removed with a chisel and hammer in order to control surface contamination and structural damage as much as possible. Samples were put under airtight polyethene and labelled with their exact location and position, and taken to the conservation materials laboratory to be analysed in controlled humidity conditions (40-45% RH). Anything mercantile in the field existed under the authorities of the provincial heritage authority, approval and supervision.

Figure 4. Sampling of deteriorated wall mortar for laboratory analysis

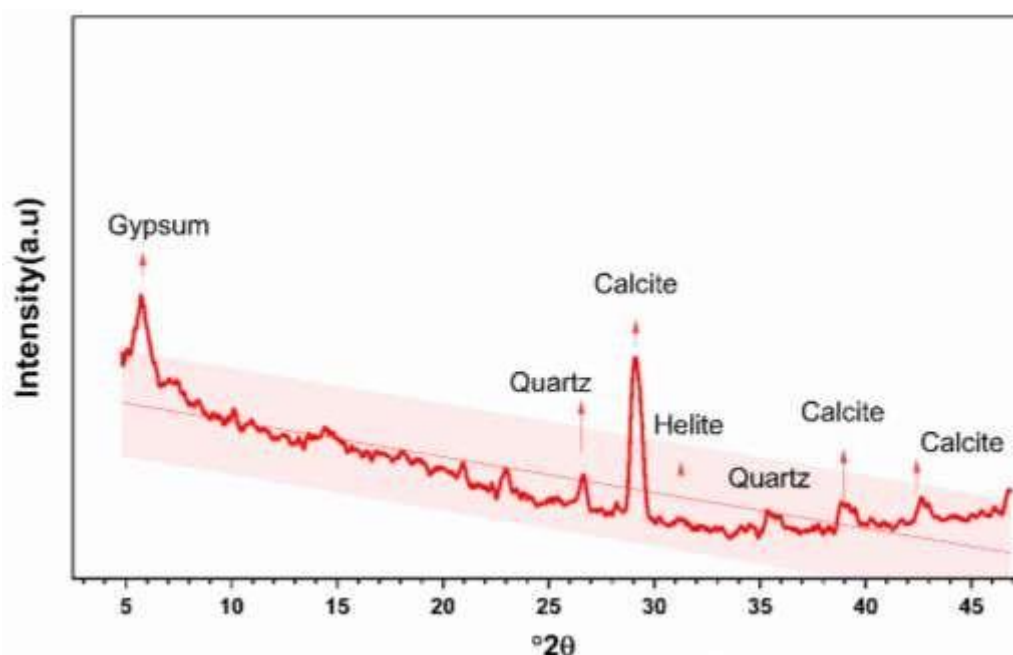
The combination of calcite, quartz, gypsum, and halite indicates both original compositional features and secondary deterioration mechanisms, aligning with the microstructural observations from SEM-EDX.

Figure 8. XRD diffractogram of the historic wall mortar (Sample 3). The major peaks correspond to calcite and quartz, confirming a lime–sand composition. Minor peaks indicate gypsum and halite.

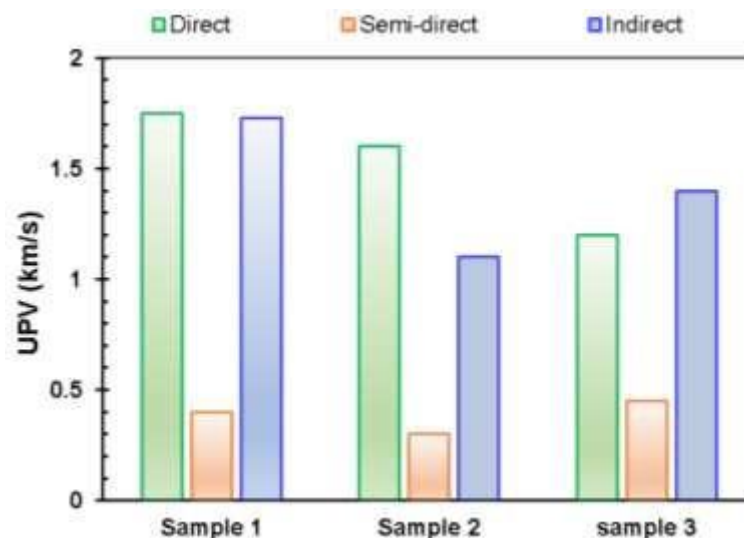
Ultrasonic testing indicated the internal cohesion and the structural integrity of the historic mortar, which was of great value for quantitative purposes. Recorded pulse velocities varied from 0.43 km/s to 1.75 km/s, with a mean of 1.48 km/s for all the measured locations. Higher velocities (>1.7 km/s) were associated with interior wall sections and indicate dense and well-carbonated lime with a small amount of voids. Moderate velocities (1.1-1.4 km/s) were observed in transitional areas, which were semi-exposed and associated with partial loss of the bonding and higher porosity. In arch segments and parapets, the speeds (below 0.8 km/s) were the lowest, and it was also observed by visual monitoring that very advanced microcracking and granular disintegration occurred.

The obtained results (Figure 10) reveal high spatial correlation between environmental exposure and internal degradation: in places with higher content of moisture and salt, the pulse velocities are obviously reduced. These values confirm a significant loss of internal cohesion and, compared with the published reference raw material and corresponding intact historic lime mortar (2.0-3.0 km/s), these values can be interpreted as milder dilation of the general structure (Moropoulou et al., 2005; Robbiola & Portier, 2006). The UPV findings therefore prove the progressive weakening of the mortar matrix even without visible damage (areas especially in the presence of moisture).

Figure 10. UPV Results of Wall Mortar
