STRENGTHENING THE RESILIENCE OF ARCHITECTURAL HERITAGE, WATERPROOFING AS A PREVENTIVE CONSTRUCTION TECHNIQUE AT THE NATIONAL MUSEUM OF BARDO-ALGIERS

Dr. Lahlou Siham

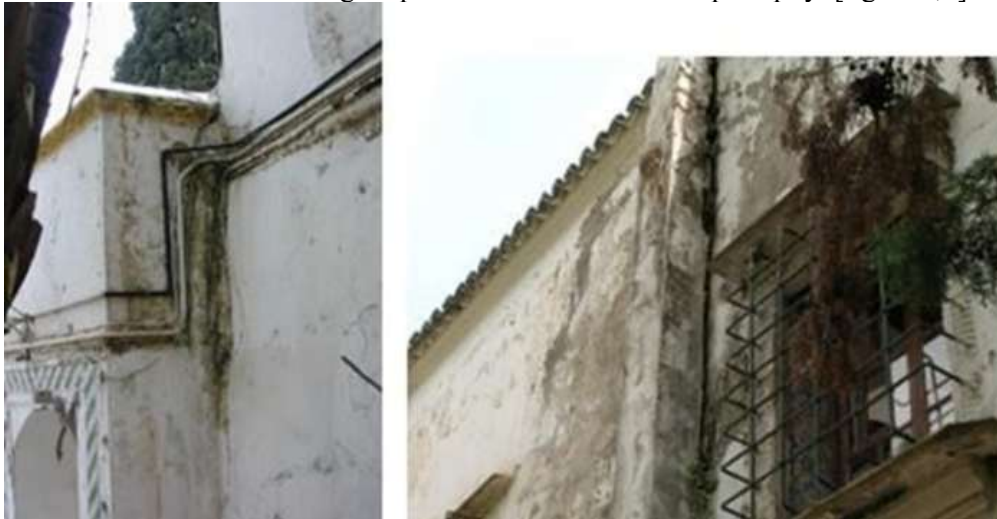
This type of humidity forms when warm, moist air comes into contact with cold surfaces, causing water vapor to condense. Waterproof coatings can worsen this phenomenon by preventing the natural evacuation of moisture. Condensation can lead to blistering in the coatings and promote mold growth, affecting indoor air quality. Various technical disorders can contribute to humidity, such as the rupture of rainwater drainage systems or the degradation of waterproofing complexes on terraces. These technical issues exacerbate humidity conditions and can lead to high repair costs if not addressed promptly. [figure 2,3]

Figure 2: The Degradation Of A Façade Due To The Rupture Of The Rainwater Drainage System (National Museum Of Bardo).

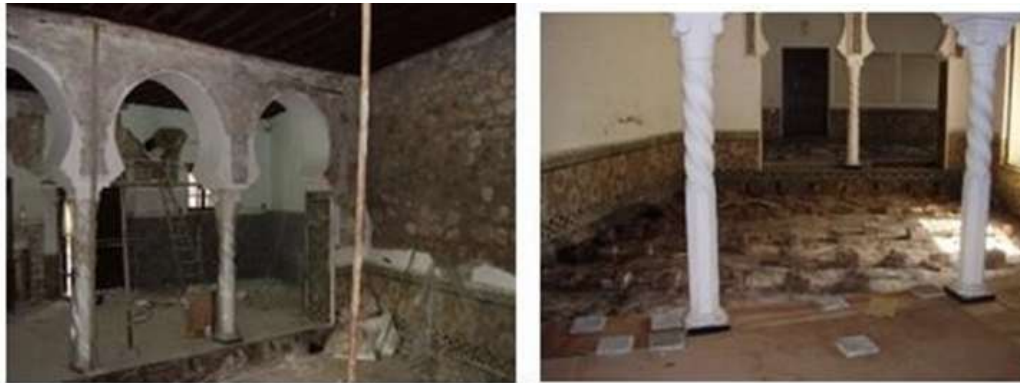
Figure 3: (Left) Mold in Interior Spaces Affecting the Tiles + Degradation of The Coatings. (Right) Stripping of The Damaged Coatings (National Museum of Bardo).

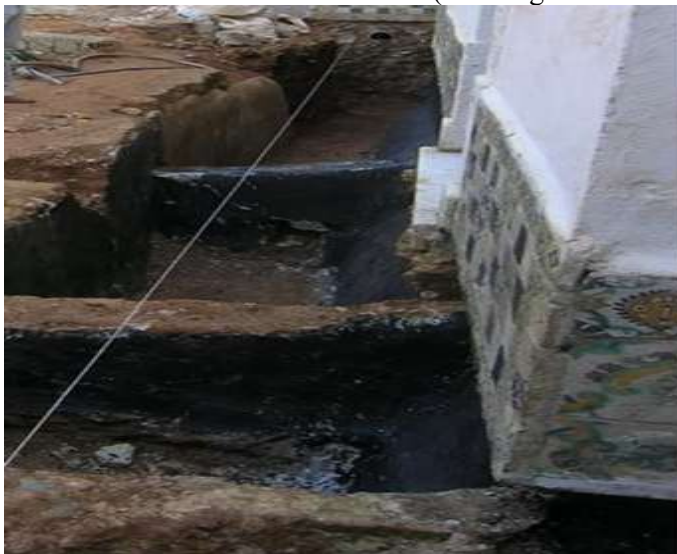
Figure 4: Construction Of Inspection Chambers for Groundwater Drainage at The Upper Courtyard. (National Museum of Bardo).

- Installation of peripheral PVC drains at the base of the foundations, connected to a system of inspection chambers leading to the final discharge.
- Creation of ventilated walls (former garden basin and Moorish café). [figure 4]

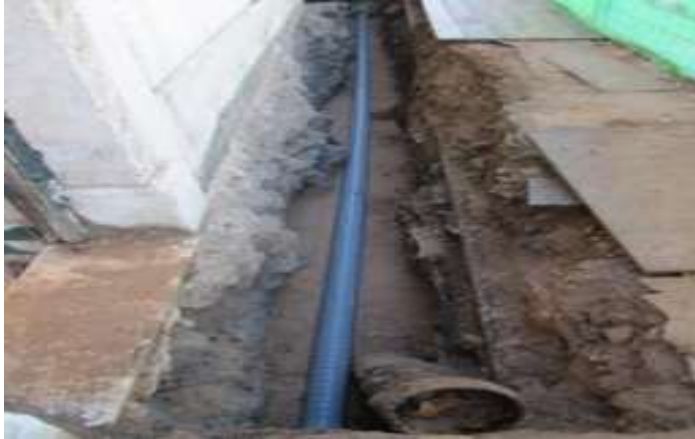
Figure 5: Installation Of the Drain at The Base of The Foundation on The Franklin Roosevelt Street Side. (National Museum of Bardo)

The drainage work was carried out at depths sometimes reaching three meters. The goal of the peripheral drainage is to prevent water accumulation around the foundations. This involves installing drainage systems that redirect rainwater away from the walls, thereby minimizing infiltrations. [figure 5]

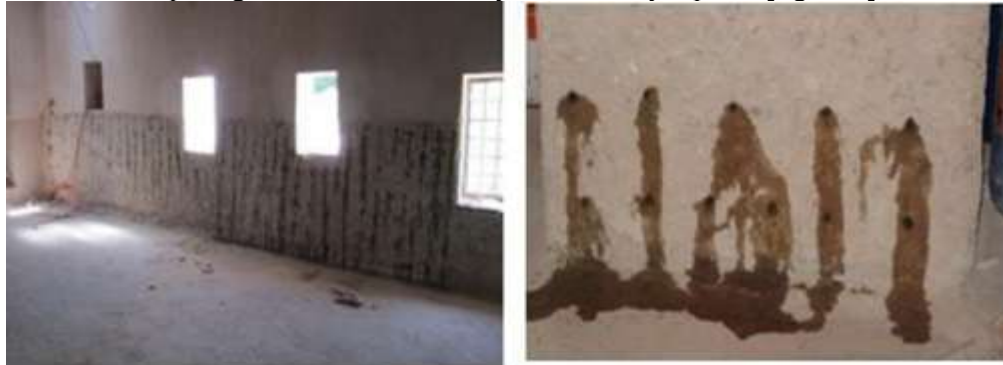
Figure 6: Drilling And Injection of a Waterproofing Solution (Prehistory Room) (National Museum of Bardo)

It is also crucial to apply a waterproofing agent to all walls in contact with the ground to prevent water penetration and protect the structure. Therefore, the injection must be carried out in perfectly masonry walls, sometimes requiring the craftsman to carry out masonry repairs. [figure 6]

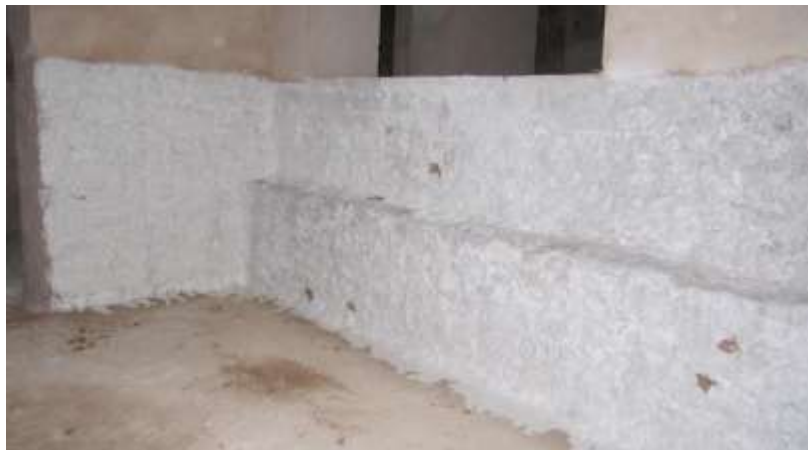
Figure 7: Moisture Treatment Wall: Anti-Salt Barriers) (National Museum of Bardo)

The management of hygroscopic salts is another important step, requiring an accurate assessment of their concentration. Specific treatments, such as washing or the application of suitable products, may be necessary to reduce their impact. To simultaneously address both rising and lateral moisture, a combination of techniques is often implemented to ensure a comprehensive and effective approach. [figure 7]
